Got Pollution?

Mattole River Watershed

Two Pollutants: Two Integrated Solutions

Mattole Restoration Council: one of the nation's oldest community driven watershed organizations.

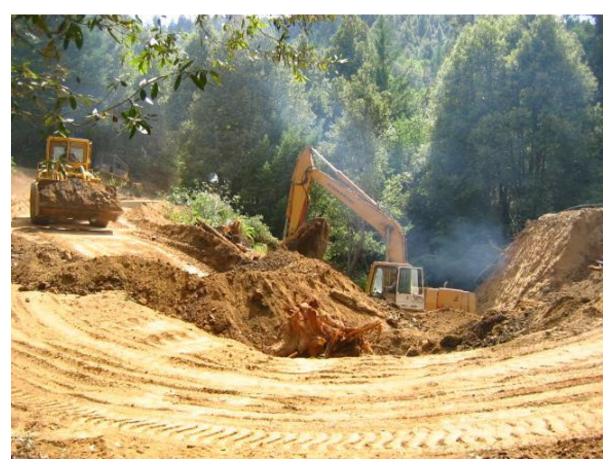
Good Roads, Clear Creeks Program

Addresses Sediment Pollution on a Basin-wide Scale

- Three Main Project Types:
 - RoadUpgrade/Stormproofing
 - Stream crossing upgrades
 - Road reshaping for improved drainage
 - Road Decommissioning
 - Stream crossing excavation
 - Road segment recontouring
 - Streambank Stabilization
 - Bioengineered riprap
 - Channel Realignment

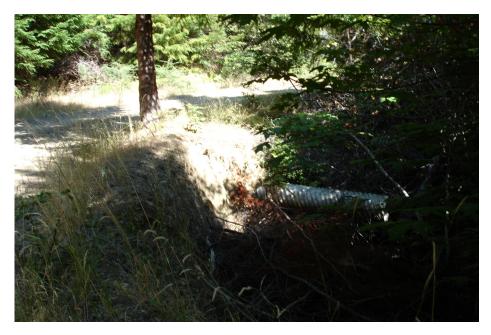
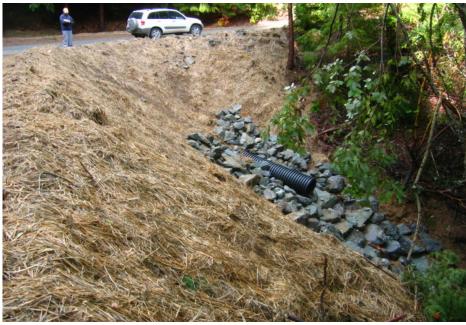
Road Upgrades – Basic Culvert Installation

- Culvert is sized properly and placed deep in the fill.
- Rip rap is placed around the culvert outlet for energy dissipation and fill stabilization
- Fill slope is compacted at a stable angle and mulched

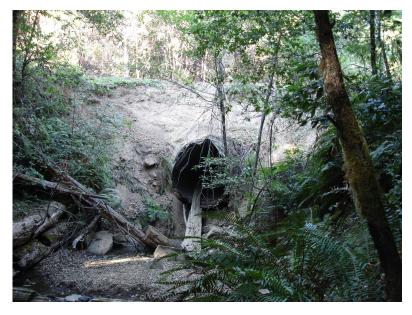
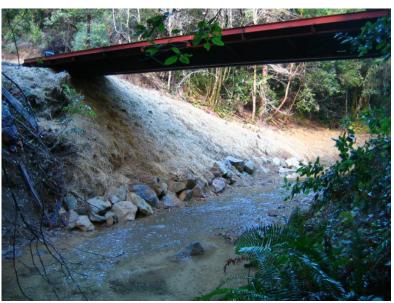
Road Upgrade – Class I Stream Crossing

Crossing upgrades on class I streams have to be completed to fish passage standards. These sites often yield some of the highest sediment pollution reduction.

- Bottomless structures such as a bridge or arch culvert are best in most cases.
- Excavation of 3000 cubic yards of sediment was completed at this site in the Whitethorn Project Area

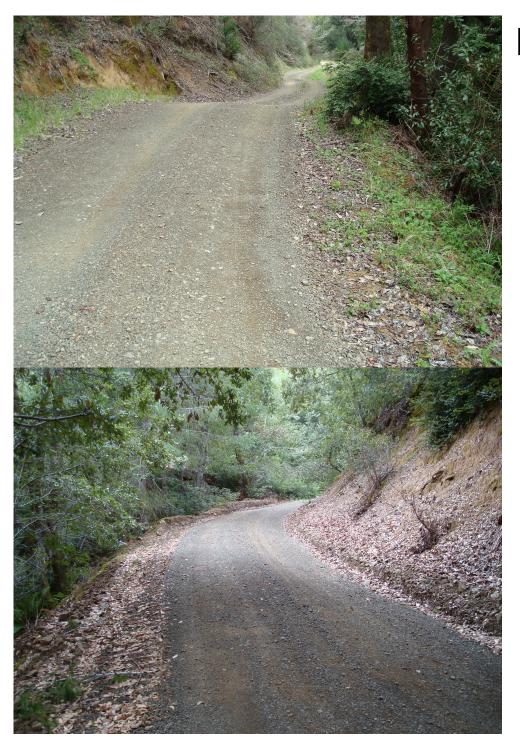
Road Upgrade – Road Surface Reshaping

These post-project photos show roads reshaped with a rolling dip and crowning.

- Reduce road surface erosion by crowning, out-sloping or dipping the road so water flows off the surface
- All reshaped roads are surfaced with gravel
- Ditch relief culverts or rolling dips disperse inboard water before it can cause erosion

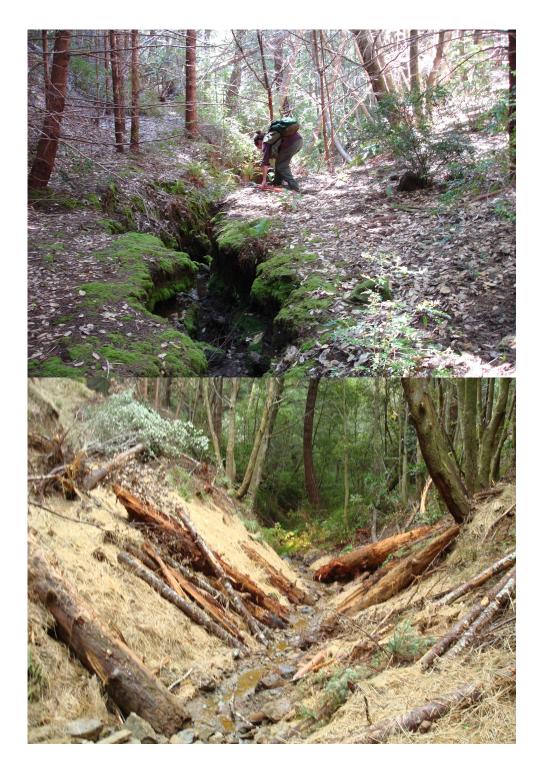
Road Decommissioning – Crossing Excavations

These pre and post project photos taken from the same location demonstrate a typical excavation of a historic logging road

- All sediment was excavated from the channel and stored in a stable location
- Small machinery was used at this site to minimize the footprint of decommissioning work on this park-like setting
- Small boulders and cobble were mined from a rock outcropping nearby and used to armor the newly excavated stream channel

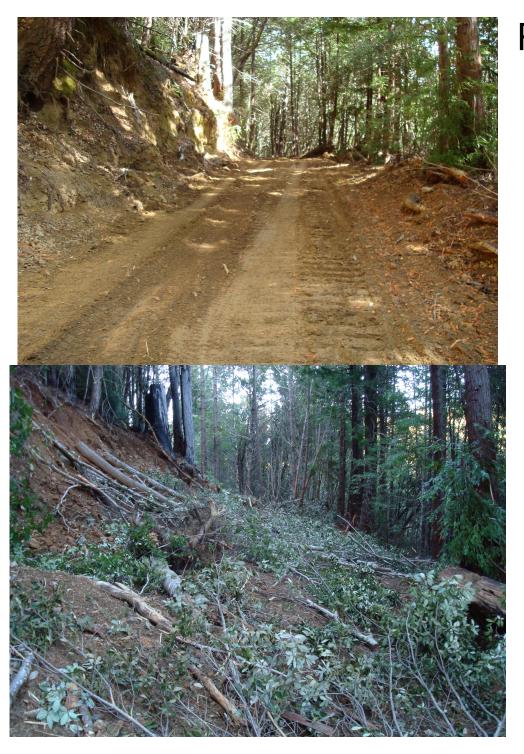
Road Decommissioning

These photos were taken from the same location along a segment of old logging road in the Ancestor Creek watershed near the headwaters of the Mattole River.

- Old logging roads cause sedimentation when water is concentrated on the road surface and erodes gullies
- In addition these old roads are proven to disturb natural groundwater infiltration

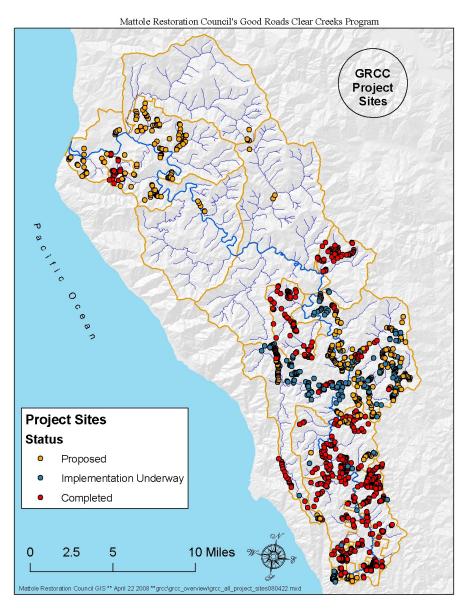
Good Roads Clear Creeks Project Site Locations

- Work done between 2002-2007
- Over 600 sites spread across the watershed at various phases of the restoration process
